340 Borough Road Footbridge
Principal Inspection
North Tyneside Council

22 February 2011

North Tyneside Council

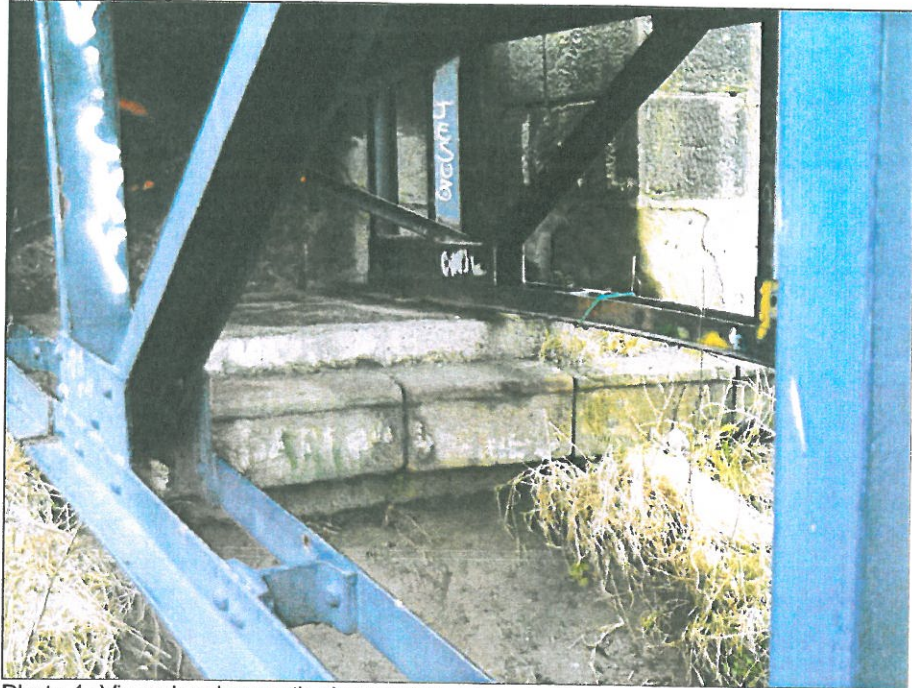
- Algal staining was noted to the surface of the abutment (photograph 2).
- Growth of vegetation to the abutment shelves, between the masonry blocks was noted (photograph 1).
- Mortar loss and open joints were noted to the block masonry to the west of the abutment (photograph 2).

Photo 1: View showing north abutment bearing shelf

- De-vegetation of the abutments and cleaning of algal staining is required over both abutments.
- Masonry repair works (e.g. re-pointing etc. as required) should be undertaken to the abutments and piers.

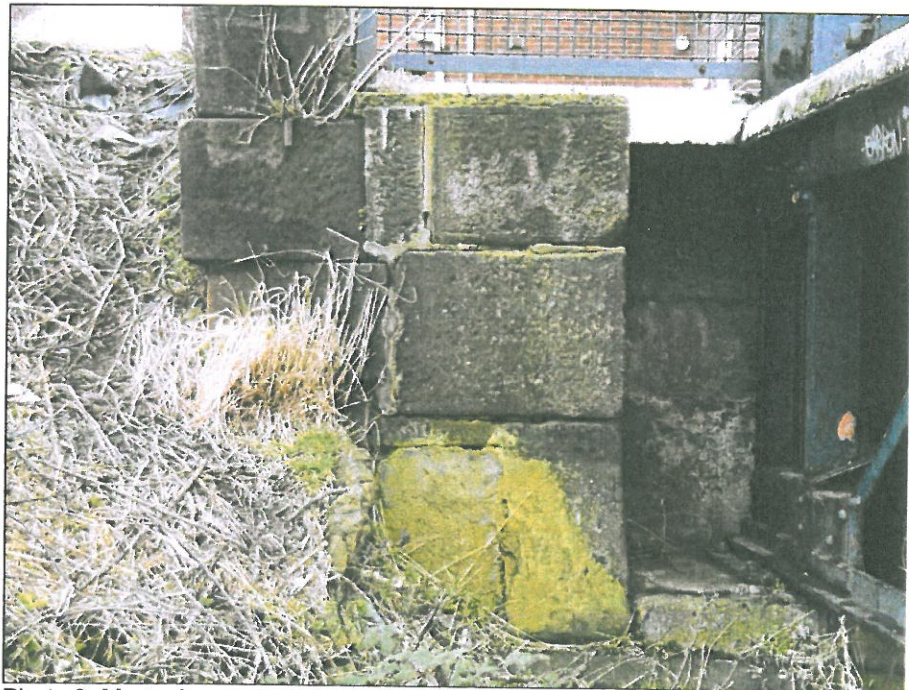
Photo 2: Mortar loss, open joints and algal staining at north abutment

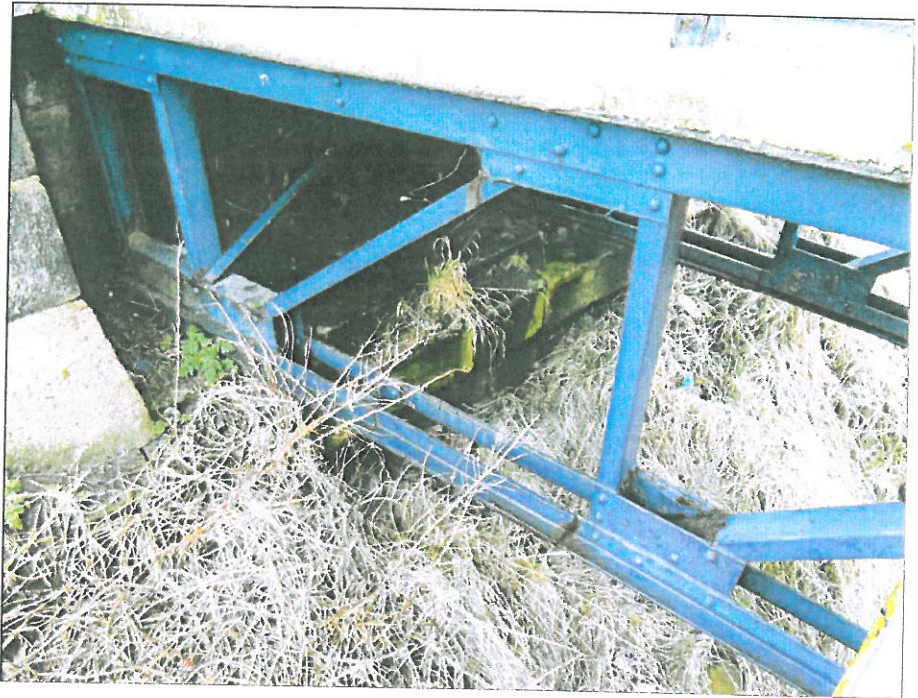
- The south abutment was found to be subject to algal staining for most of the visible surface area with rust stains on the bearing stones (photograph 3).
- Growth of vegetation to the abutment shelves, between the masonry blocks was noted (photograph 3).
- Displaced blocks and open joints were noted to the block masonry to the east of abutment (photograph 4).

Photo 3: Algal staining and vegetation growth to the south abutment bearing shelf

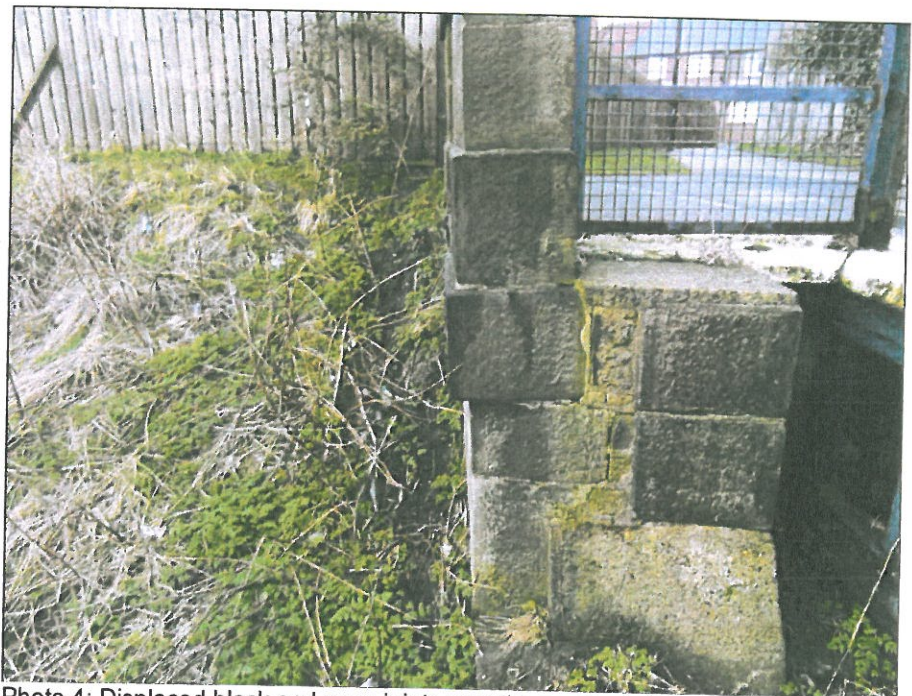
Photo 4: Displaced block and open joints over the south abutment

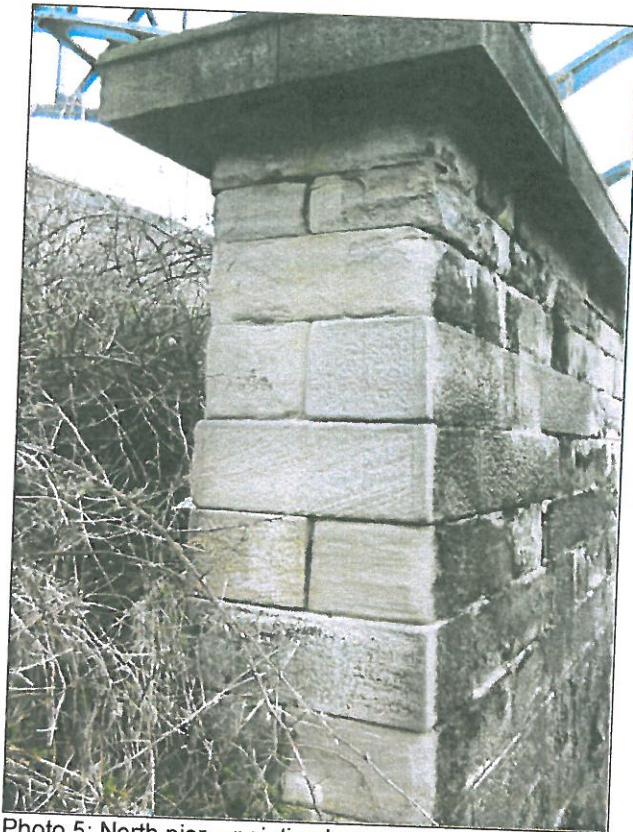
- Both of the piers were noted to have pointing loss (upto 25% of surface area) due to weathering (photographs 5, 6).
- Dry staining and soot deposits were observed on both of the pier surfaces (photographs 7 & 10).
- The bearing pad of the north pier is showing signs of scaling (photograph 9).
- Algal staining and vegetation growth was noted to the top of the pier surfaces (photograph 8).

Photo 5: North pier – pointing loss at the top of pier (east face)

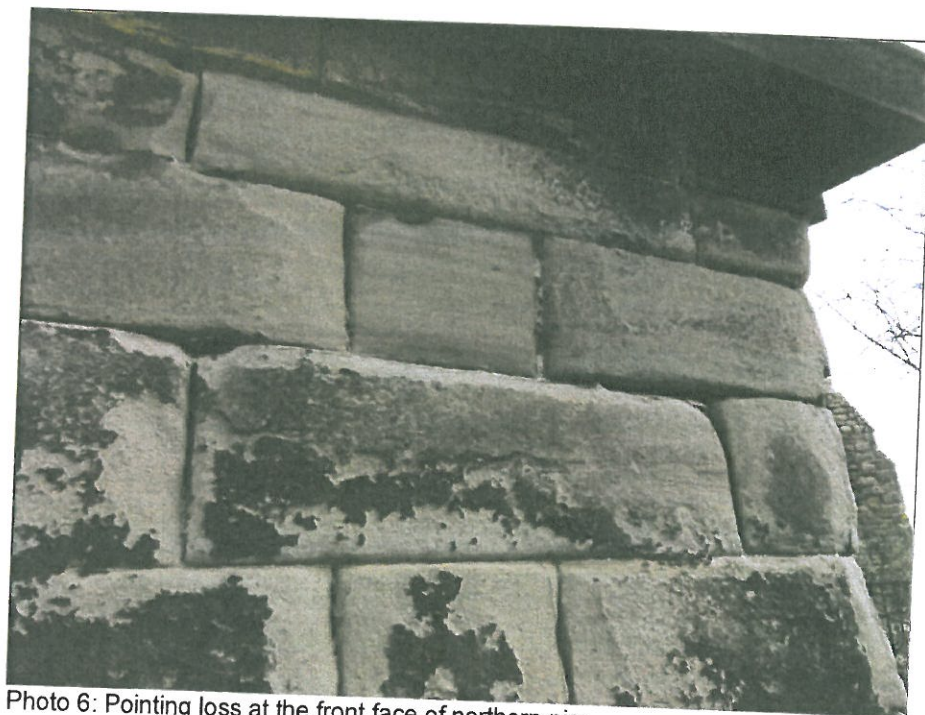
Photo 6: Pointing loss at the front face of northern pier

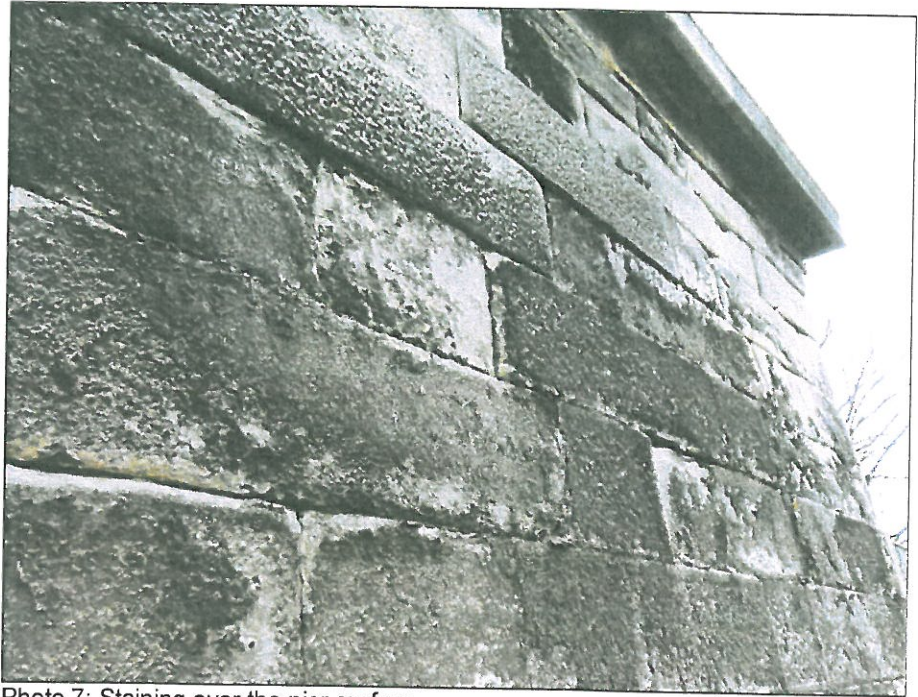
Photo 7: Staining over the pier surface

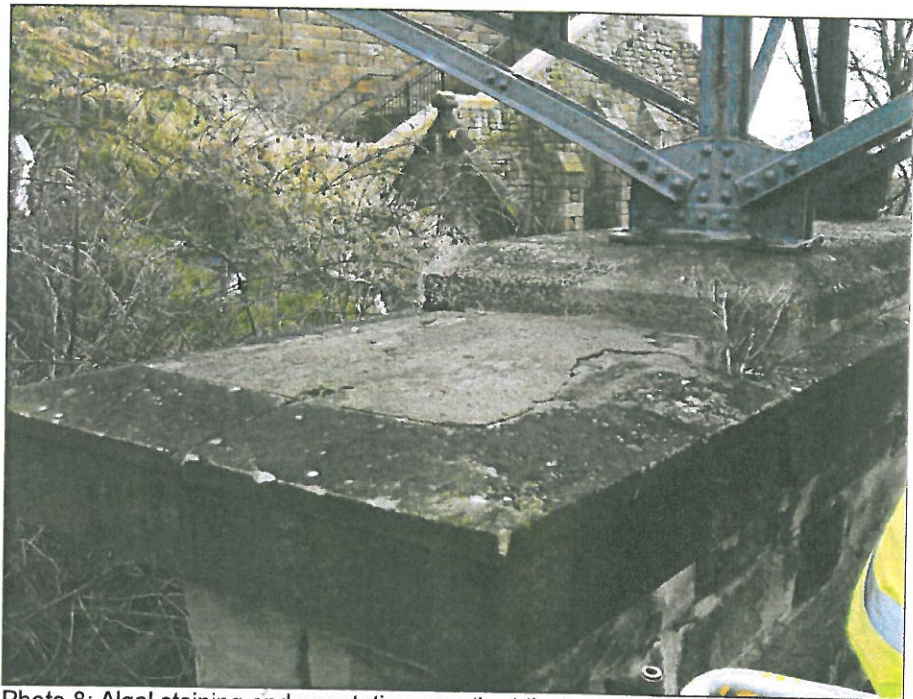
Photo 8: Algal staining and vegetation growth at the top of north pier

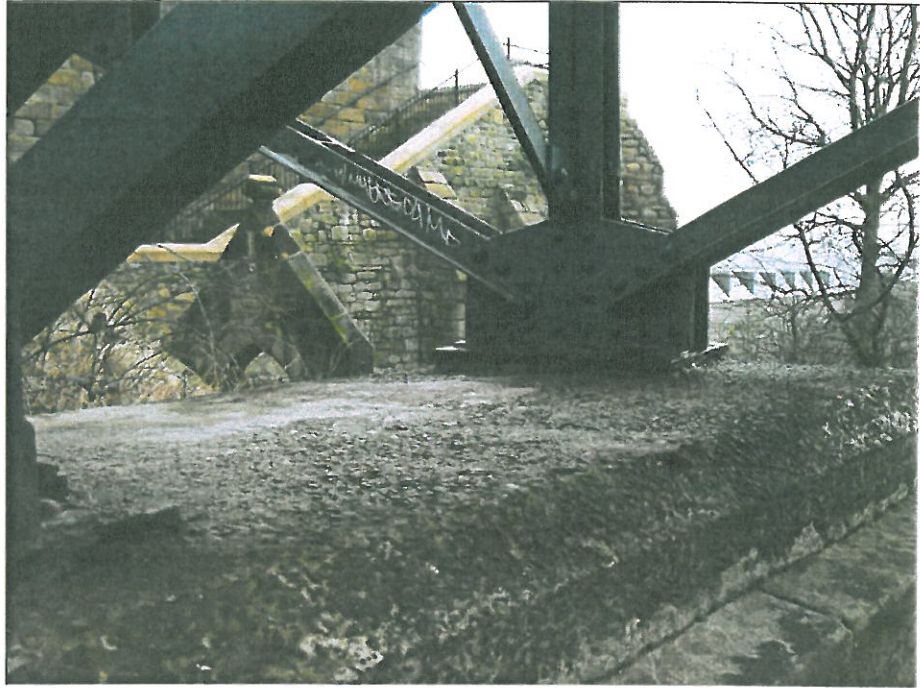
Photo 9: Scaling at the bearing plinth over the northern pier

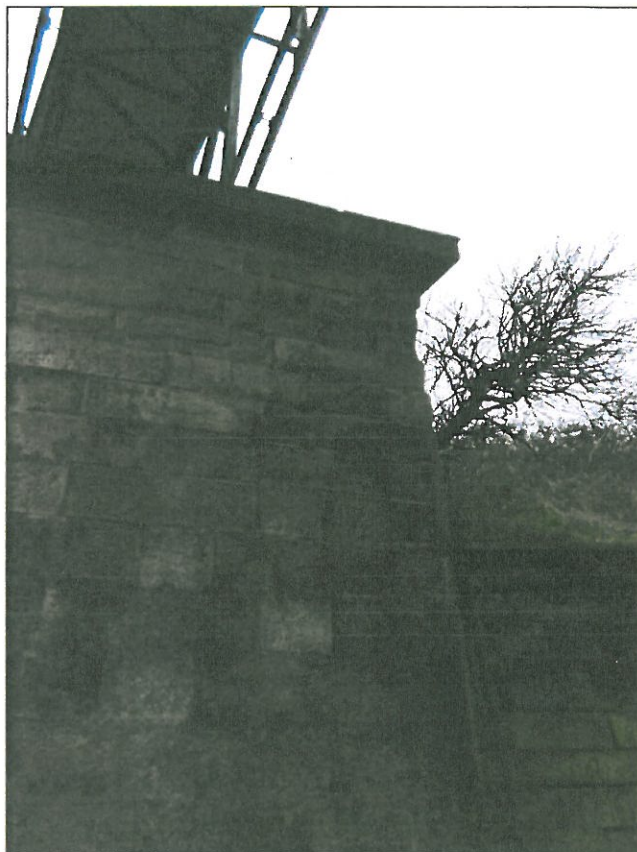
Photo 10: View of south pier- condition similar to north pier

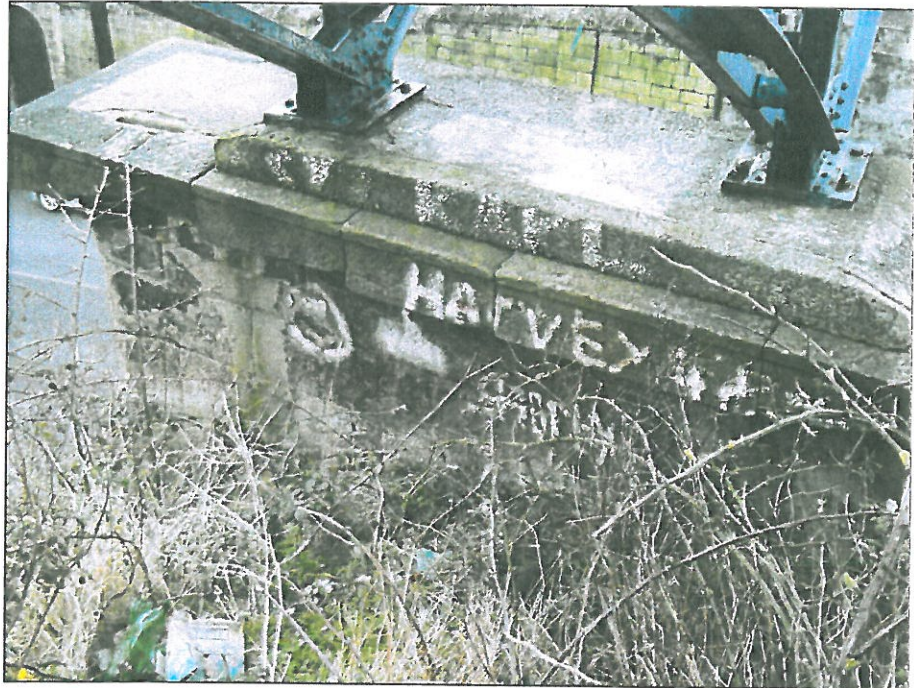
Photo 11: Graffiti at the pier elements

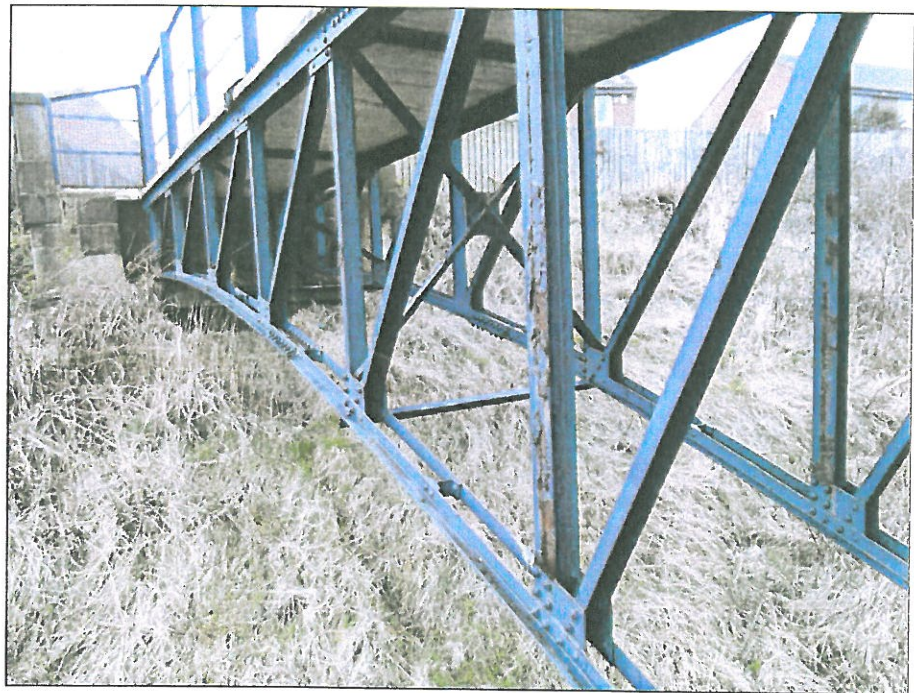
- The steel members were found to have paint loss and associated corrosion in general. Minor steel flaking has occurred at a few places, also due to failure of the paint coating (photographs 12 – 18).
- Corrosion is more severe at the connection of the superstructure to the abutment and piers. Steel flaking was also observed at these locations (photographs 19, 20).

Photo 12: View showing paint failure and associated corrosion on the superstructure

- It is recommended that a special inspection is undertaken to verify the existing paint condition of the superstructure, as per BD 87/05. Following the inspection, appropriate actions should be adopted in accordance with the guidance.

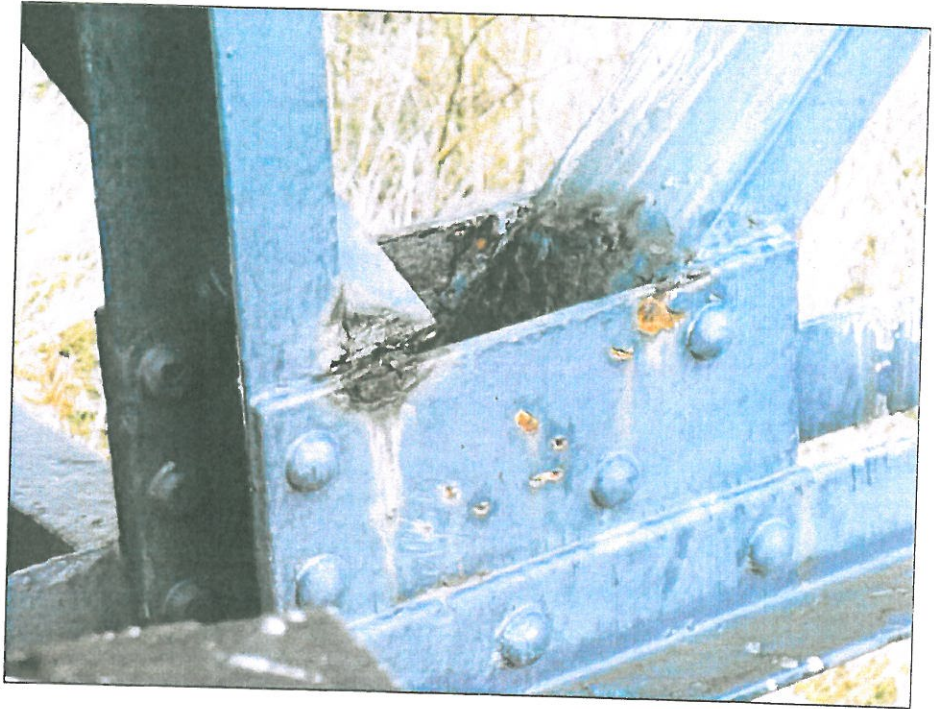
Photo 13: Paint failure and associated corrosion at the connection – typical

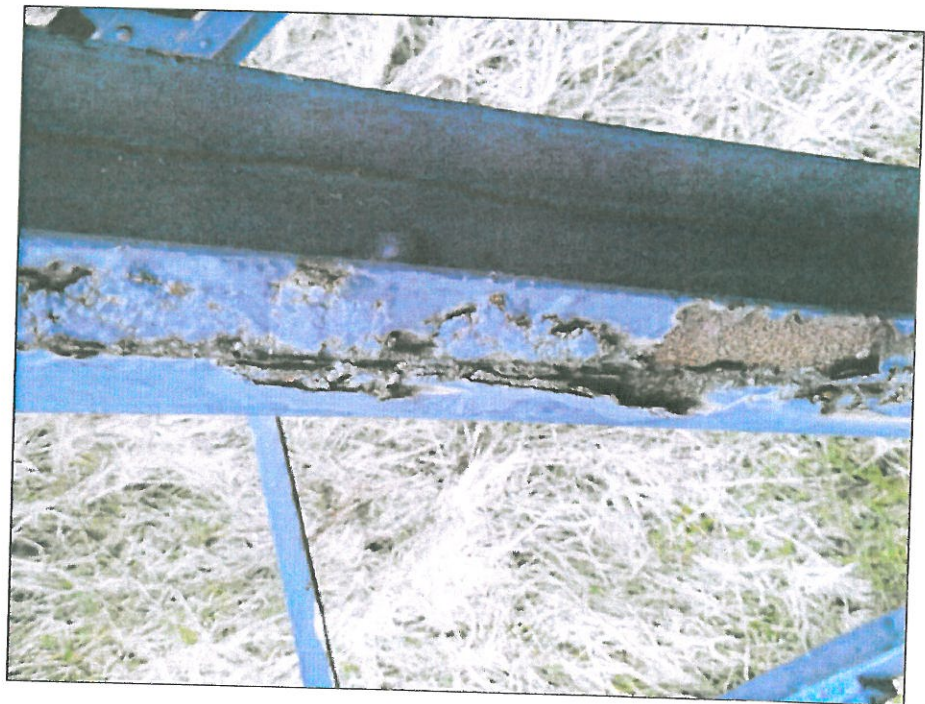
Photo 14: Another view of paint failure and associated corrosion on superstructure

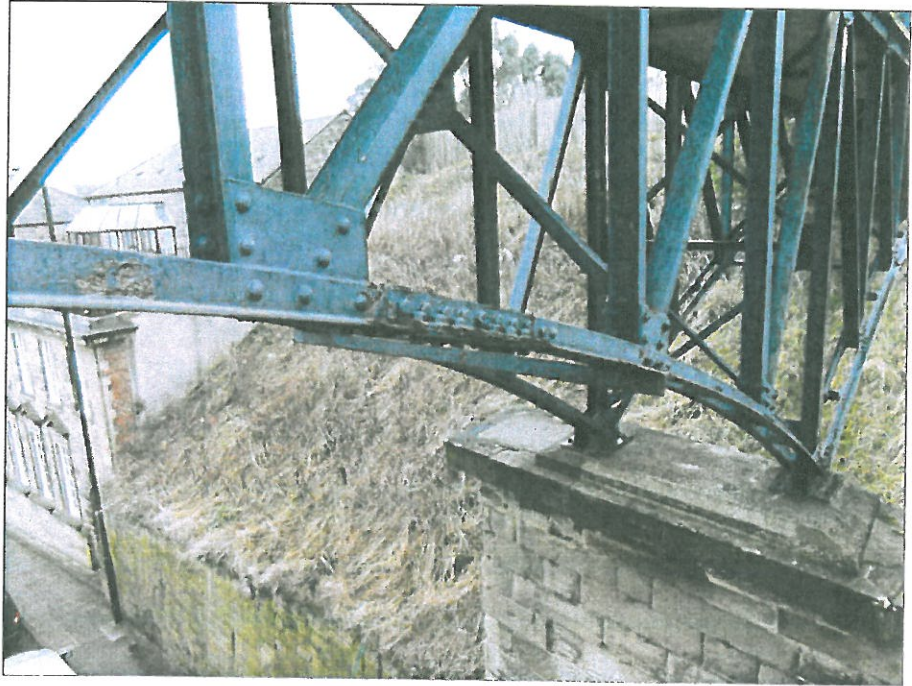
Photo 15: Paint failure and associated corrosion at splice connection

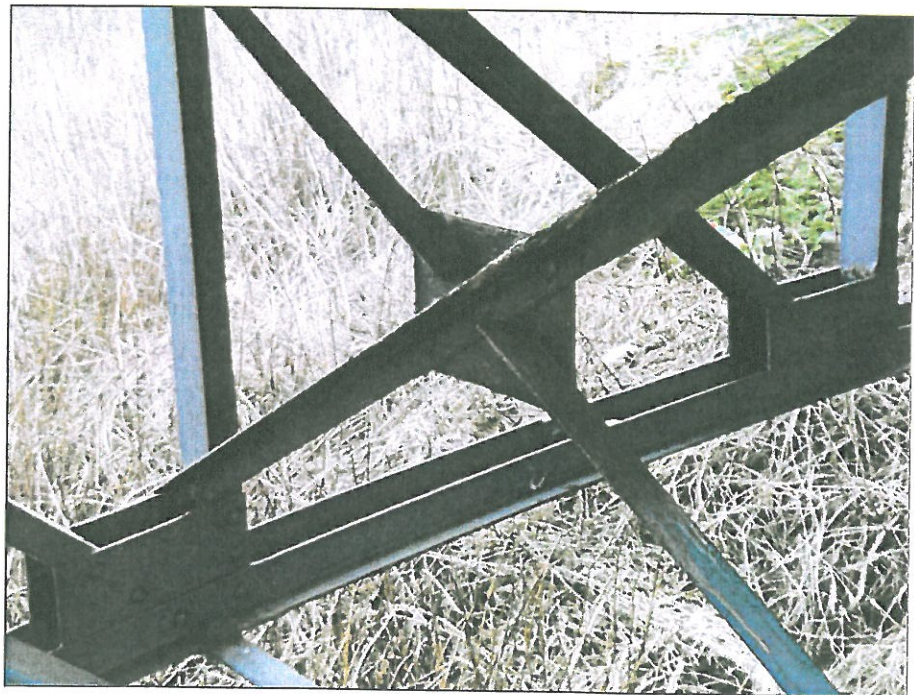
Photo 16: Paint failure and associated corrosion on the bracing members

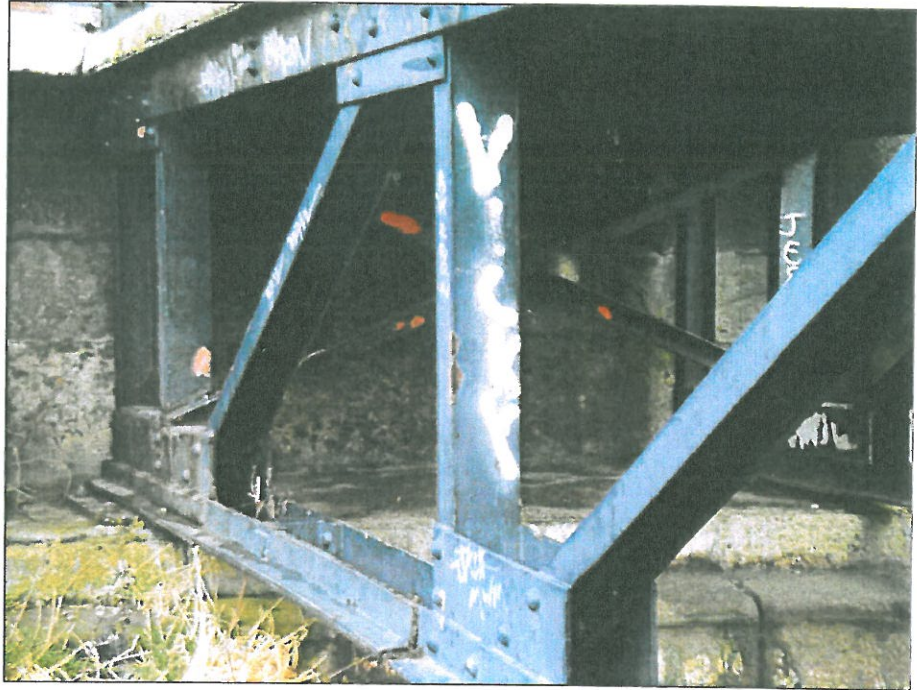
-
- Graffiti was noted on the steel members near to the abutments (photograph 17).

Photo 17: Graffiti on superstructure members

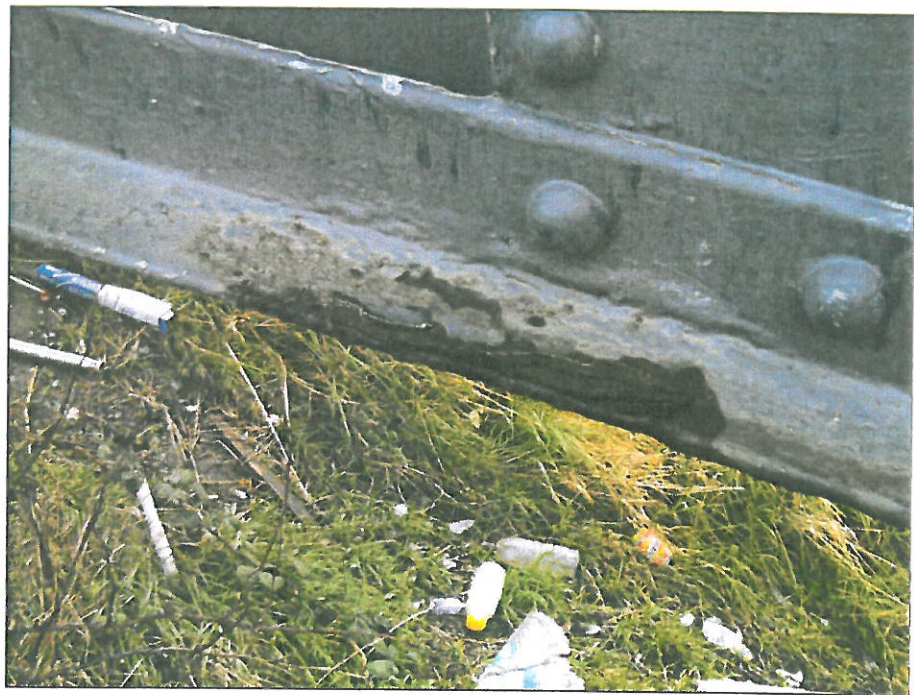
Photo 18: Steel flaking at the steel member

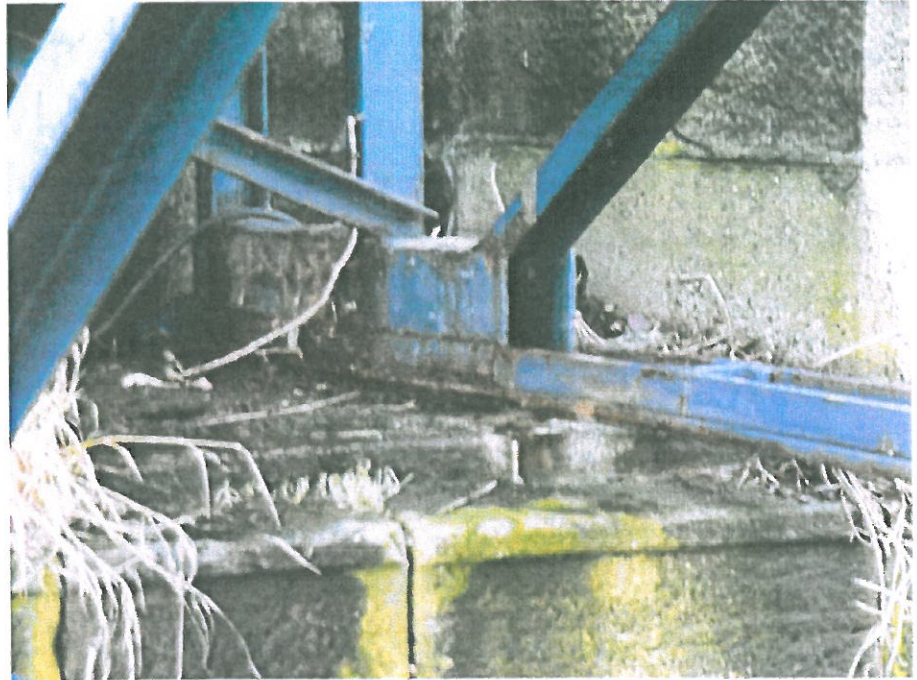
Photo 19: Corrosion to steel members over the abutment connection – typical

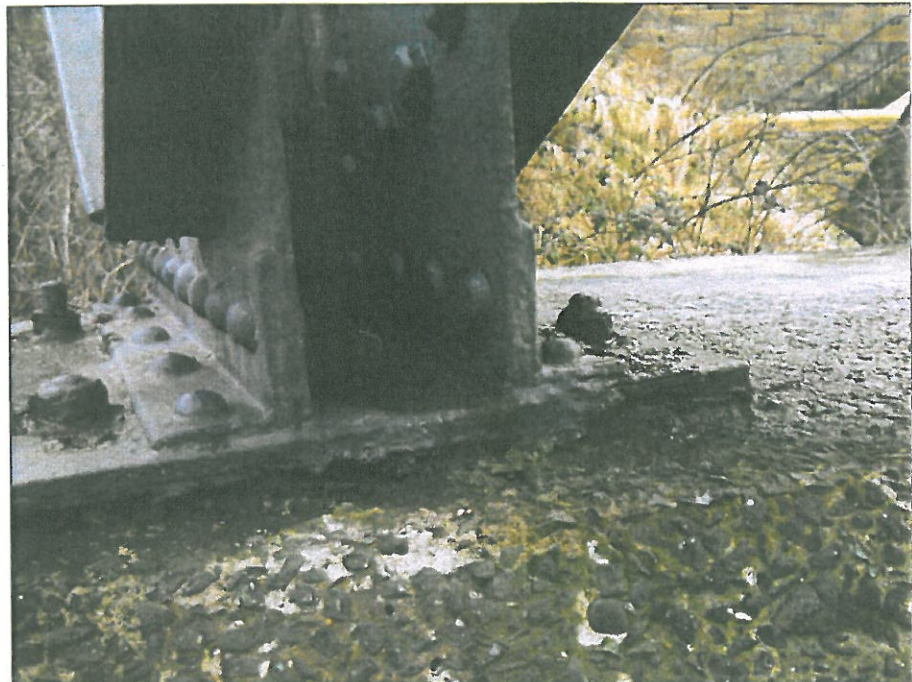
Photo 20: Corrosion and steel flaking at the pier connection – typical

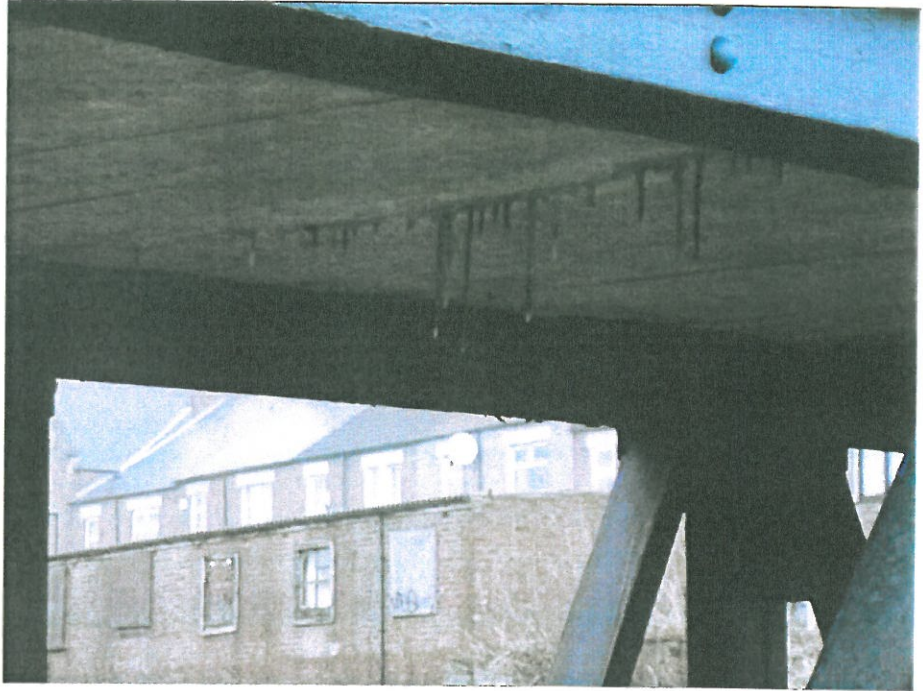
- Accumulation of calcites was noted at a few locations to the deck soffit (photograph 21).
- Algal staining and minor honeycombing was observed on the edges of the deck slab (photograph 22).

- The bridge deck soffit was generally found to be dry apart from instances of accumulation of calcites at a few locations. This is most probably due cracks on the footway surfacing that are allowing water penetration through the deck (photograph 21).

Photo 21: Accumulation of leaching salts on the deck soffit - typical

- The footway surfacing should be renewed to prevent water penetration through the deck.

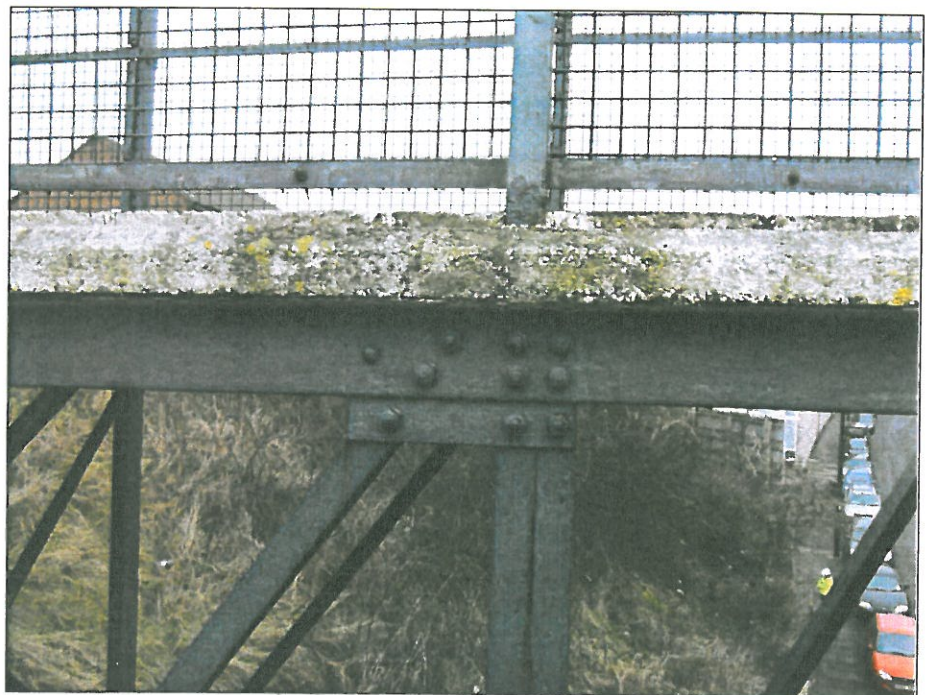
Photo 22: Algal staining and honey combing over the deck edges

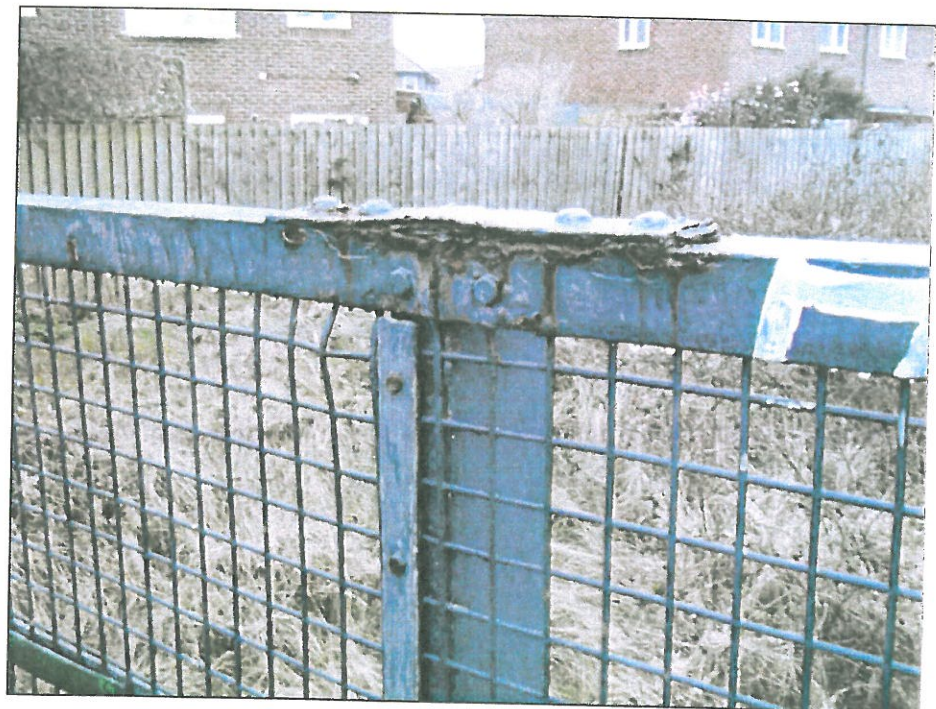
- Moderate corrosion was noted to the connection of vertical and horizontal posts at the top (photograph 24).
- General paint failure and associated minor corrosion was observed to the parapet members at a few locations (photograph 25).
- Minor pointing loss has occurred on the masonry approach parapets (photograph 28).

Photo 24: Paint failure and steel flaking at top of parapet – typical for few locations

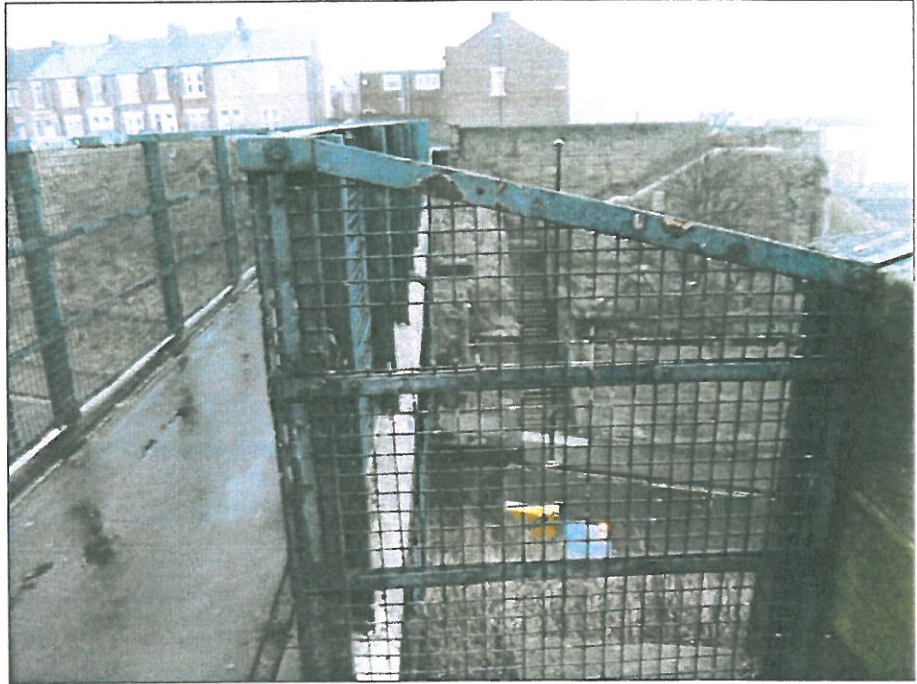
Photo 25: General paint failure and associated corrosion to parapet members

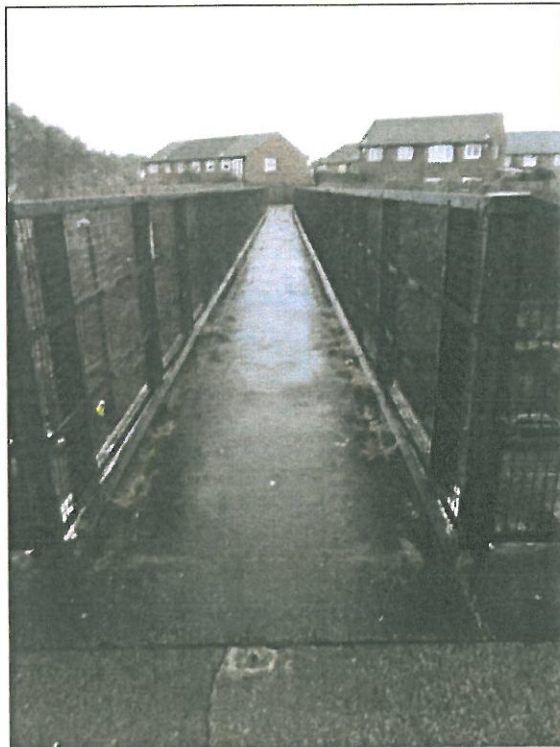
- Cracks were noted to the top layer of the footway surfacing (photograph 27). The concrete surfacing over the approaches is also showing the signs of cracking (photograph 28).
- Vegetation growth was observed to the edges of the footway for the whole length of the footbridge (photograph 26).

Photo 26: View of footbridge surfacing showing vegetation at the edges of footway

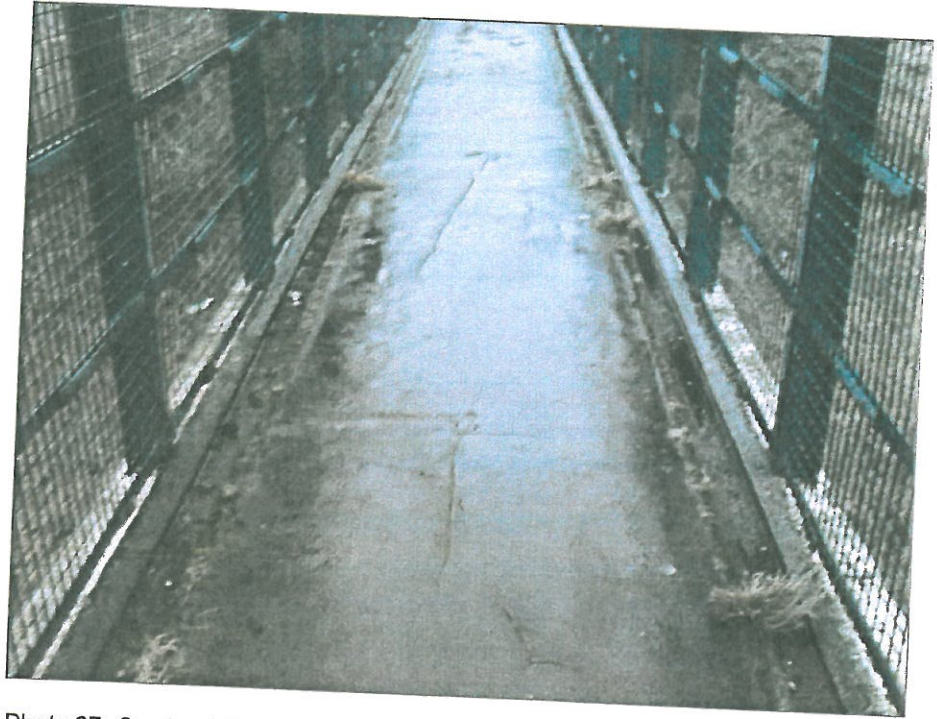
Photo 27: Cracks visible on the top of surfacing

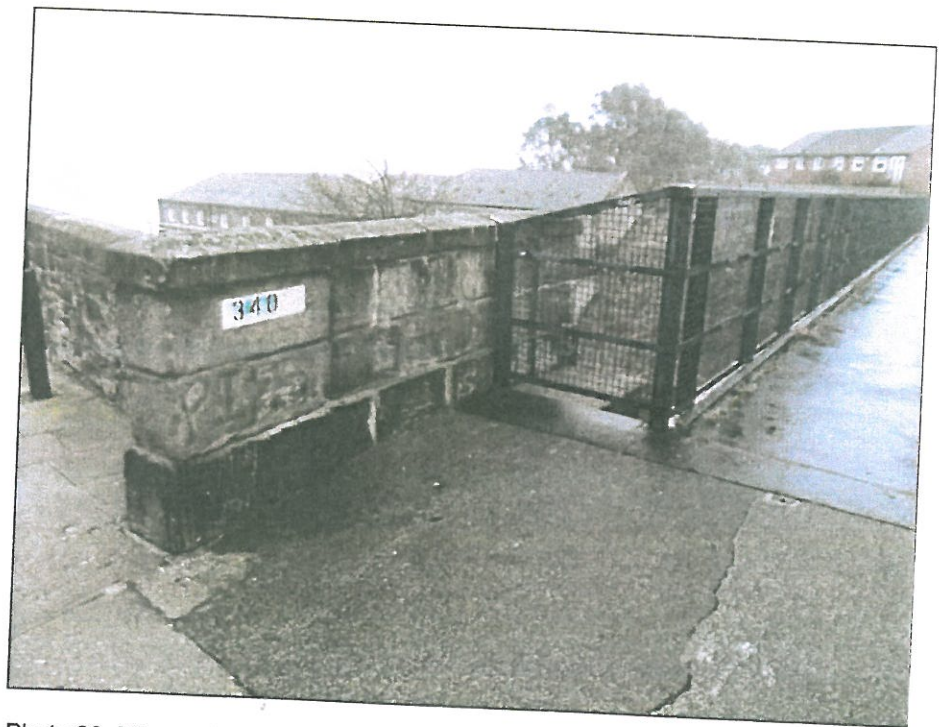
Photo 28: Minor pointing loss over the approach parapets

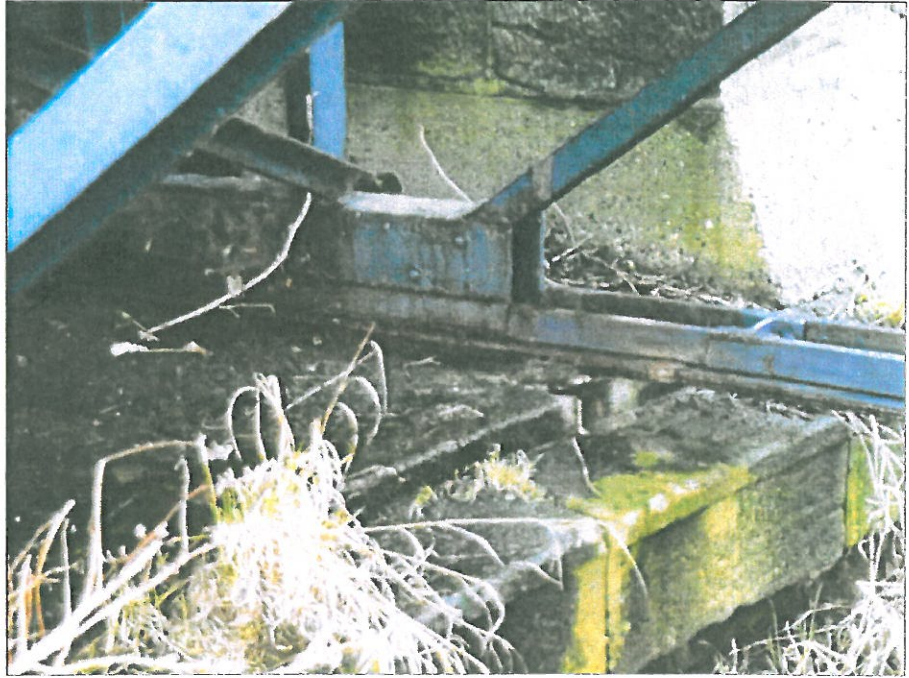
- The abutment bearing plates under the longitudinal members are believed to be corroded as is indicated by rust stains to the abutments (typical photograph 29).

Photo 29: Corroded bearing plate under the longitudinal steel members
