North Tyneside Council

Asbestos Survey Report 23/01/2018-25/01/2018 Management Survey

PL1424
White Swan Centre
White Swan Centre
Citadel E
Killingworth
Newcastle upon Tyne
NE12 6SS

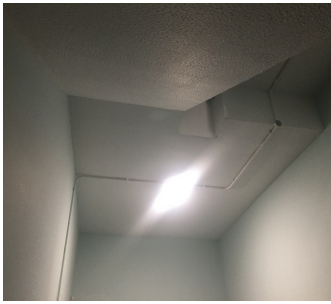
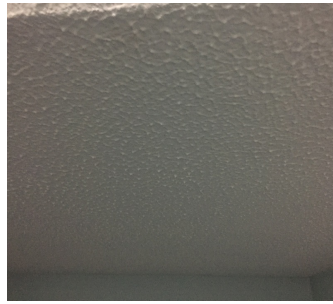
Item ID	Textured coating to ceilings(OS)
Sample/link ID	S001 - AJ002453
Property Name	White Swan Centre
Area/floor	L1
Room/location	011
Specific location	Ceiling
Product/debris type	Plaster/plasterboard Lining
Extent	40 m ²
	  No Risk

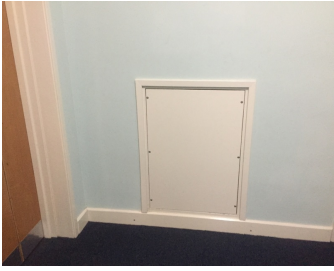
Room/location Reference:	012
Room/location Description:	
Area/floor Reference:	L1
Area/floor Description:	Level 1
Accessibility:	Inaccessible
Reason for No Access:	Damage to Decoration
Total ACMs:	0
Total NoACMs:	0

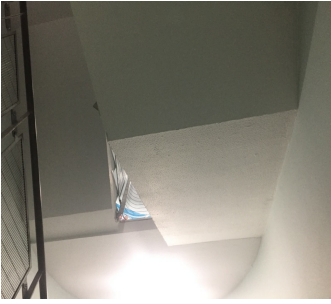
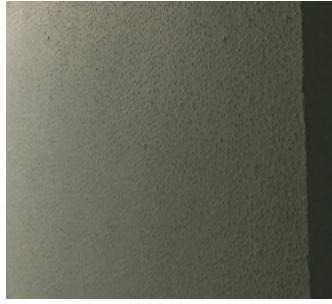
Item ID	Textured coating to ceilings(VRS)
Sample/link ID	S001 - AJ002453
Property Name	White Swan Centre
Area/floor	L1
Room/location	021B
Specific location	
Product/debris type	Plaster/plasterboard Lining
Extent	20 m ²
	■ No Risk

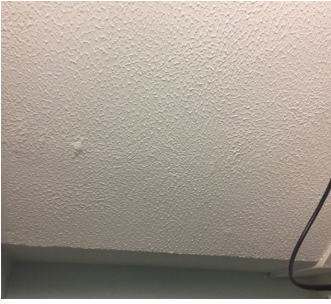
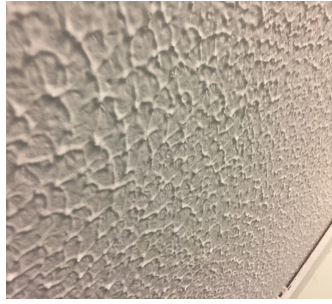
Item ID	Textured coating to ceiling (VRS)
Sample/link ID	S001 - AJ002453
Property Name	White Swan Centre
Area/floor	L1
Room/location	021F
Specific location	
Product/debris type	Plaster/plasterboard Lining
Extent	8 m ²
	■ No Risk
