North Tyneside Council

## Hartley Cove to the River Tyne Coastal Strategy

### Technical Report 4: Existing Defences & Historical Expenditure

May 2014

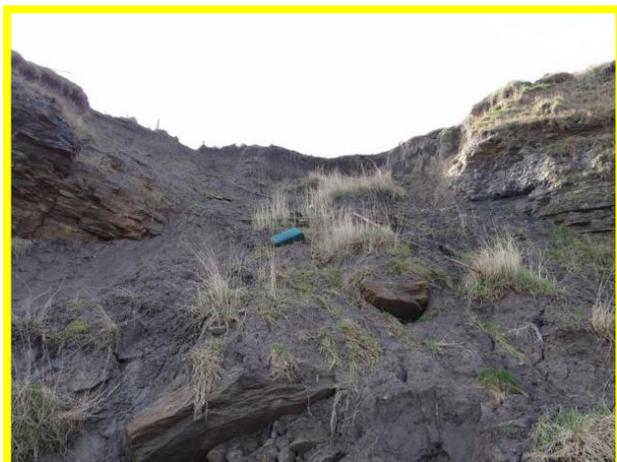
This Management Area covers the coastline from the northern boundary of the study area at Hartley Cove to Curry's Point in the south, a distance of approximately 1km. There are 4 coastal defence assets in this MA, mainly cliff frontage with a couple of manmade access points. All assets are in fair condition and there are no particular issues to be noted. There is some erosion and slumping of the cliffs, for example adjacent to the access steps at Hartley Cove (asset 121AA901A4401C23).

**Figure 2-1 Slumping/erosion of cliff adjacent to Hartley Cove steps**

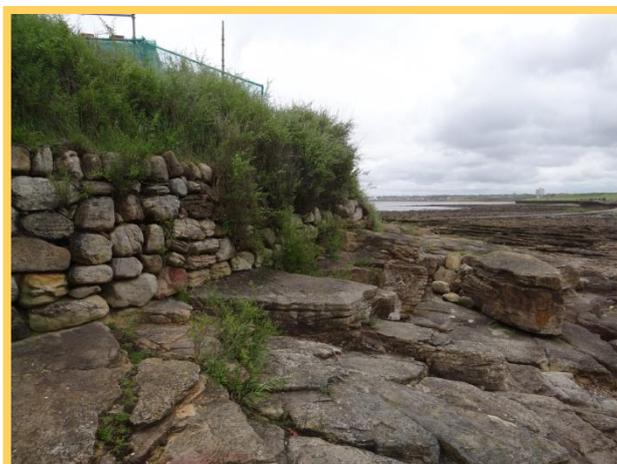
**Figure 2-2 121AA901A4501C01**

2.2.7 On St. Mary's Island there is a wall fronting properties on the western side of the Island (121AA901A4501C01) that is in Poor condition, grade 4, with undermining and vegetation growing through the wall in places. St. Mary's causeway (7105A) is condition grade 3, Fair, but has minor areas that need maintenance for cracking and there is an area of undermining at the westward end adjacent to Trinity Road sea wall (121AA901A4501C04). The lighthouse has been identified during consultation for SMP2 as an important heritage asset.

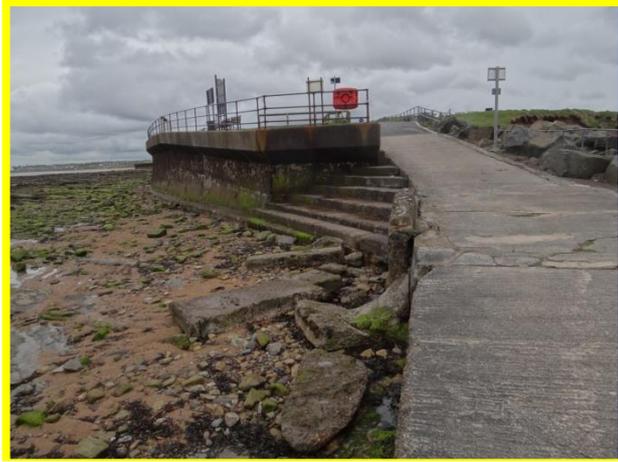
**Figure 2-3 7105A St. Mary's Causeway**

7105A	Causeway	Mass concrete causeway to St. Mary's Island	180	22/05/2014	Causeway has a patchwork of repairs and cracks and displacement of edge beams and minor undermining but appears to be regularly maintained	3	6-10	Repair cracking and undermining	Routine
121AA901A4501C04	7105	Sea wall	Trinity Road Sea Wall – concrete sea wall fronted by rocky/sandy beach	645.6	13/03/2014	Sea wall in good condition. Minor loss of sealant in some joints and minor cracking. Erosion at southern end adjoining cliff.	3	>20	Replace sealant and fill cracks	Routine

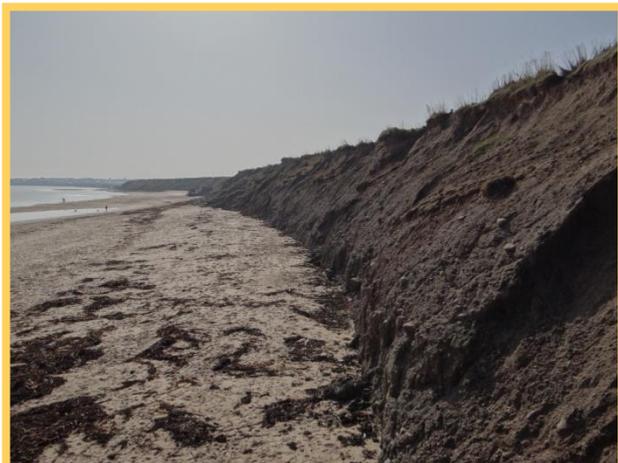
**Figure 2-4 121AA9014501C05**

- 2.2.8 The soft cliff south of Trinity Road sea wall (121AA901A4501C05) is actively eroding and slumping. There is an area of erosion at its juncture with the sea wall that is starting to outflank the wall. At the time of writing North Tyneside Council have a scheme in place to provide erosion protection to a short length of the cliff using concrete blocks, known as T-blocks, to halt this outflanking.

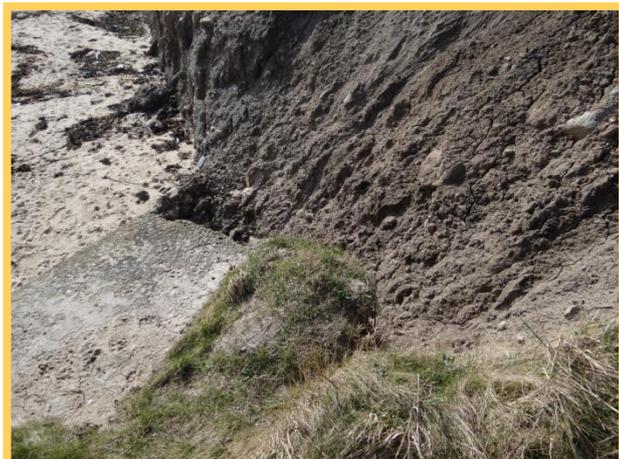
**Figure 2-5 Erosion outflanking Trinity Road seawall**

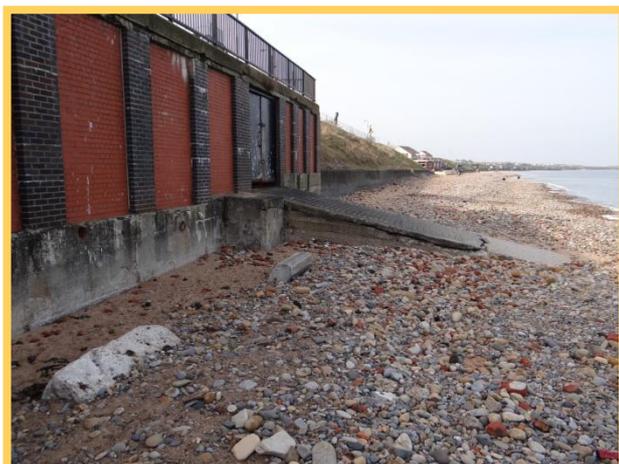
**Figure 2-6 121AA901A4601C02**

- 2.2.9 There are two other assets that have been classified as condition 4, Poor, following the inspections and these are towards the southern end of MA25. These are the Northern Promenade (121AA901A4601C02) and Lower Central Promenade (121AA901A4601C03). Both suffer from abraded and spalling concrete surfaces. Northern Promenade has cracking in the access ramp and steps and Lower Central Promenade has displaced coping.

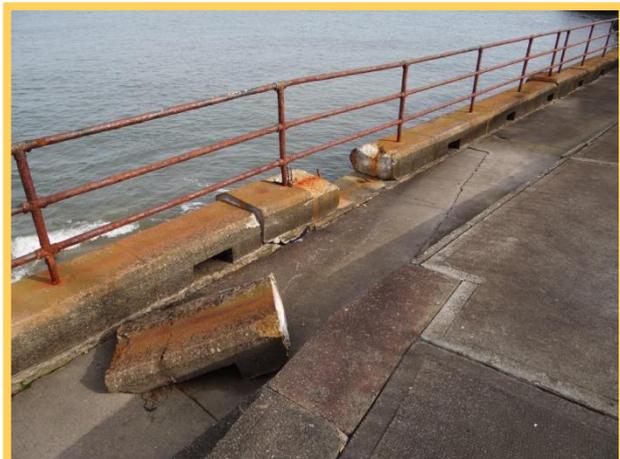
**Figure 2-7 121AA901A4601C03**

121AA901A4601C03	7111	Sea wall	Lower Central Promenade – concrete sea wall with gunite render fronted by sandy beach	165.4	13/03/2014	Poor/fair condition with spalling on facing. Displaced coping.	4	11-20	Repair render and coping	Routine
121AA901A4601C04	7112	Sea wall	Central Promenade – curved block wall with masonry crest fronted by sandy beach	108.2	13/03/2014	Good condition	3	>20	None	Routine
121AA901A4601C05	7113	Sea wall	Central Promenade – straight concrete block wall fronted by sandy beach	54.1	13/03/2014	Generally good condition with heavy staining. No cracking or movement evident	3	>20	None	Routine
121AA901A4601C06	7114	Sea wall	Central Promenade – curved block wall with masonry upper wall	50.4	13/03/2014	Good condition. Concrete toe exposed possibility of undermining. Leaching/staining	3	>20	None	Routine

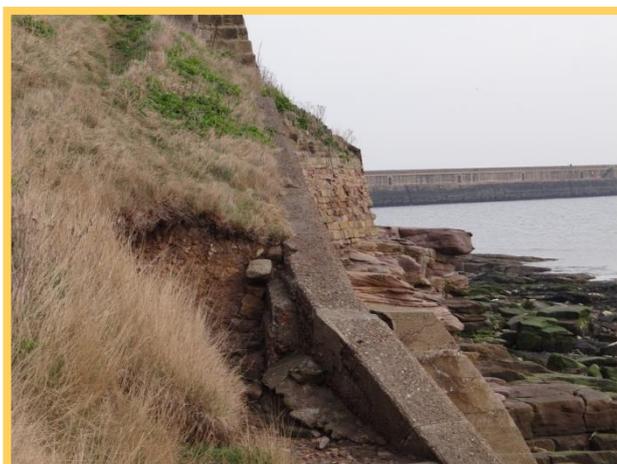
**Figure 2-8 121AA901A4801C06**

- 2.2.17 Within MA27 there is one asset that is graded as 4, Poor, at Freestone Point (121AA901A4801C06). This is a short length of masonry seawall with a concrete revetment and is extensively damaged.
