North Tyneside Council

Asbestos Survey Report 23/01/2018-25/01/2018 Management Survey

PL1424
White Swan Centre
White Swan Centre
Citadel E
Killingworth
Newcastle upon Tyne
NE12 6SS

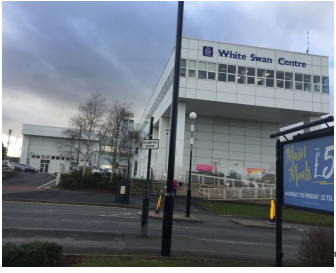
Room/location Reference:	E99
Room/location Description:	External
Area/floor Reference:	E
Area/floor Description:	External
Accessibility:	Accessible
Total ACMs:	0
Total NoACMs:	0

Comments: Plastic skylight, modern air handling units, modern air con fans, metal cladding, limited access to externals of building due to height restrictions and no safety rails to roof

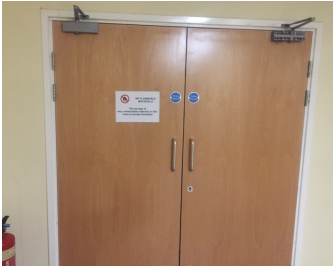
Room/location Reference:	001
Room/location Description:	
Area/floor Reference:	L1
Area/floor Description:	Level 1
Accessibility:	Inaccessible
Reason for No Access:	Previously surveyed
Total ACMs:	0
Total NoACMs:	0

Comments: Boiler room previously surveyed

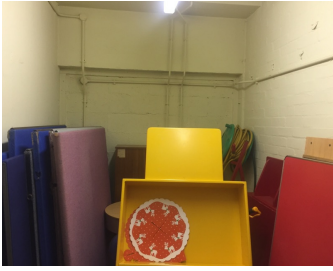
Room/location Reference:	003
Room/location Description:	
Area/floor Reference:	L1
Area/floor Description:	Level 1
Accessibility:	Accessible
Total ACMs:	0
Total NoACMs:	0

Comments: Modern electrics, machine made mineral fibre and foam insulated pipes, modern fire resistant plasterboard panel to wall, limited access stored items

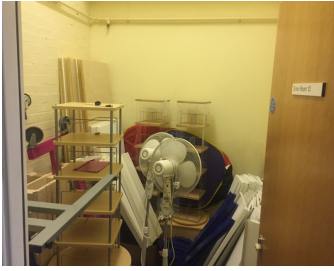
Room/location Reference:	004
Room/location Description:	
Area/floor Reference:	L1
Area/floor Description:	Level 1
Accessibility:	Accessible
Total ACMs:	0
Total NoACMs:	0

Comments: Limited access stored items

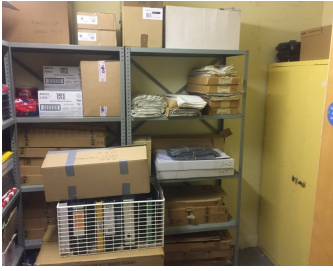
Room/location Reference:	008
Room/location Description:	
Area/floor Reference:	L1
Area/floor Description:	Level 1
Accessibility:	Accessible
Total ACMs:	0
Total NoACMs:	0

Comments: Machine made mineral fibre insulated pipes, limited access stored items

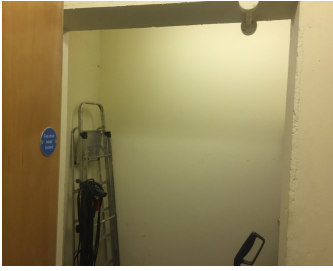
Room/location Reference:	009
Room/location Description:	
Area/floor Reference:	L1
Area/floor Description:	Level 1
Accessibility:	Accessible
Total ACMs:	0
Total NoACMs:	0

Comments: Foam insulated pipes, limited access stored items

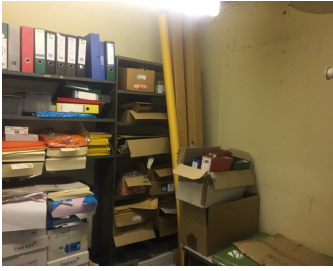
Room/location Reference:	010
Room/location Description:	
Area/floor Reference:	L1
Area/floor Description:	Level 1
Accessibility:	Accessible
Total ACMs:	0
Total NoACMs:	0

Comments: Machine made mineral fibre insulated pipes, limited access stored items

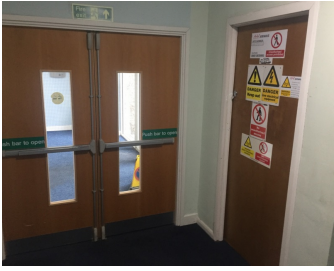
Room/location Reference:	021B
Room/location Description:	
Area/floor Reference:	L1
Area/floor Description:	Level 1
Accessibility:	Accessible
Total ACMs:	0
Total NoACMs:	1

Item ID	Textured coating to ceilings(VRS)
Sample/link ID	S001 - AJ002453
Property Name	White Swan Centre
Area/floor	L1
Room/location	021B
Specific location	
Product/debris type	Plaster/plasterboard Lining
Extent	20 m ²
	■ No Risk

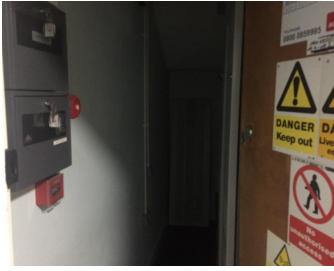
Room/location Reference:	021F
Room/location Description:	
Area/floor Reference:	L1
Area/floor Description:	Level 1
Accessibility:	Accessible
Total ACMs:	0
Total NoACMs:	1

Item ID	Textured coating to ceiling (VRS)
Sample/link ID	S001 - AJ002453
Property Name	White Swan Centre
Area/floor	L1
Room/location	021F
Specific location	
Product/debris type	Plaster/plasterboard Lining
Extent	8 m ²
	■ No Risk

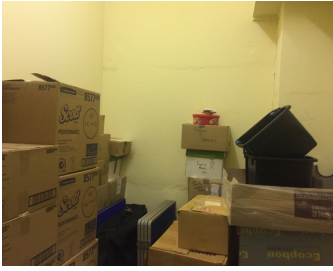
Room/location Reference:	022A
Room/location Description:	
Area/floor Reference:	L1
Area/floor Description:	Level 1
Accessibility:	Accessible
Total ACMs:	0
Total NoACMs:	0

Comments: Limited access due to stored items

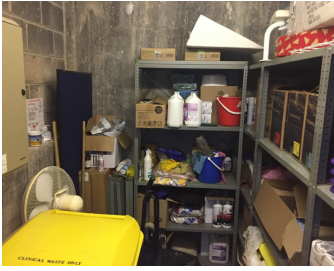
Room/location Reference:	024A
Room/location Description:	
Area/floor Reference:	L1
Area/floor Description:	Level 1
Accessibility:	Accessible
Total ACMs:	0
Total NoACMs:	0

Comments: Modern electrics, machine made mineral fibre and foam insulated pipes

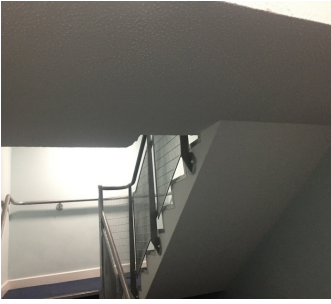
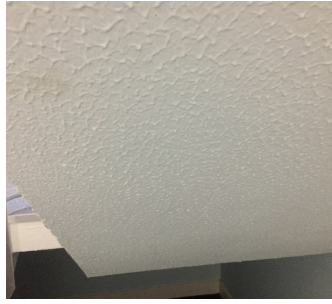
Comments: Metal radiator and pipes, modern stair nosings

Item ID	Textured coating to ceilings (OS)
Sample/link ID	S002 - AJ002454
Property Name	White Swan Centre
Area/floor	L2
Room/location	041B
Specific location	Ceiling
Product/debris type	Plaster/plasterboard Skim
Extent	40 m
	■ No Risk

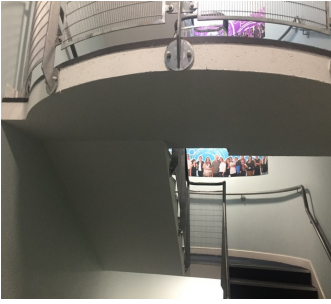
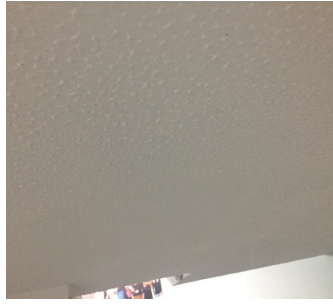
Item ID	Textured coating to ceilings (VRS)
Sample/link ID	S002 - AJ002454
Property Name	White Swan Centre
Area/floor	L2
Room/location	058
Specific location	
Product/debris type	Plaster/plasterboard Skim
Extent	40 m ²
	■ No Risk

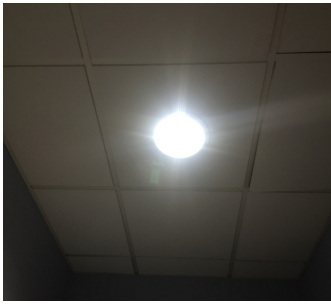
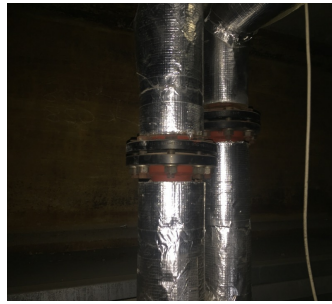
Room/location Reference:	062
Room/location Description:	
Area/floor Reference:	L3
Area/floor Description:	Level 3
Accessibility:	Accessible
Total ACMs:	1
Total NoACMs:	0

Item ID	Gaskets
Property Name	White Swan Centre
Area/floor	L3
Room/location	062
Specific location	Ceiling void
Product/debris type	Gaskets To Pipe Flange
Extent	2 Number
Accessibility/vulnerability	Medium
Additional information	N/A

Product Type (a)	N/A
Extent of Damage (b)	N/A
Surface Treatment (c)	N/A
Asbestos Fibre (d)	N/A
Total (a+b+c+d)	12
Material Risk Assessment	■ High

Location	Item
Item ID	Gaskets
Property Name	White Swan Centre
Area/floor	L3
Room/location	062
Specific location	Ceiling void
Product/debris type	Gaskets To Pipe Flange
Extent	2 Number
Accessibility/vulnerability	Medium
Additional information	N/A
Actions/recommendations	
Action/recommendations	Further Investigation Required

Product Type (a)	N/A
Extent of Damage (b)	N/A
Surface Treatment (c)	N/A
Asbestos Fibre (d)	N/A
Total (a+b+c+d)	12
Material Risk Assessment	High

Item	Sample	Product/debris Type	Area/floor	Room/location	Action/recommendations
Gaskets		Gaskets To Pipe Flange	L3	062	Further Investigation Required

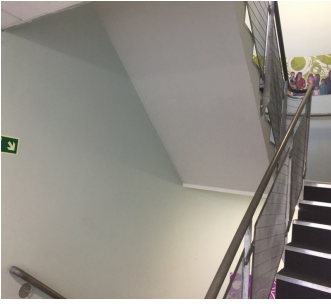
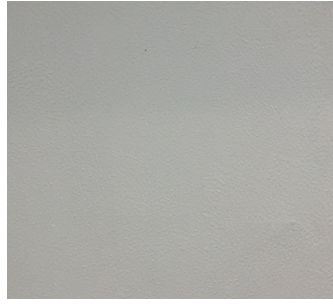
Item ID	Textured coating to ceilings (VRS)
Sample/link ID	S002 - AJ002454
Property Name	White Swan Centre
Area/floor	L3
Room/location	079
Specific location	
Product/debris type	Plaster/plasterboard Skim
Extent	10 m ²
	■ No Risk

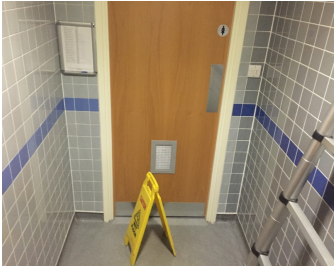
Comments: Ceramic cistern, plastic toilet toilet, modern water heater

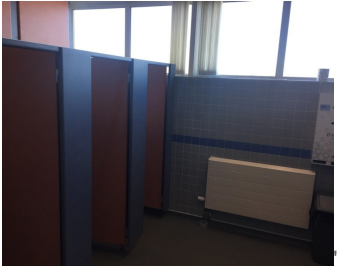
Comments: Plastic cisterns, plastic toilet toilets, metal radiator and pipes, ceramic urinals

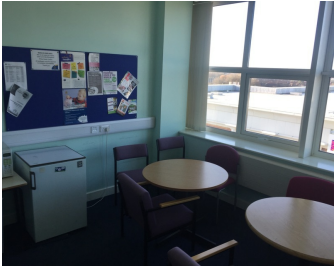
Comments: Modern sink pad

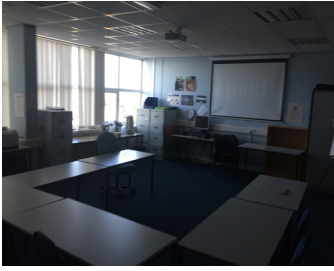
Comments: Metal radiator and pipes

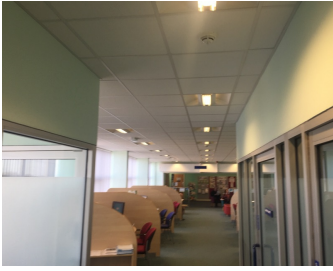
Comments: Metal radiator and pipes, concrete columns

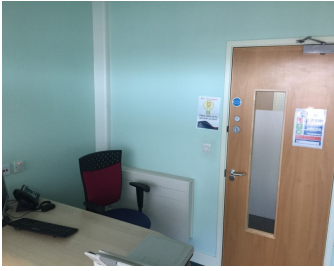
Comments: Metal radiator and pipes, plasterboard clad columns, metal shutter housing

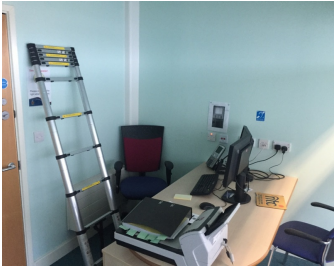
Comments: Metal radiator and pipes

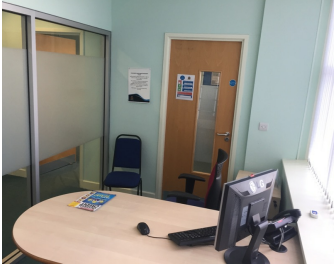
Comments: Metal radiator and pipes

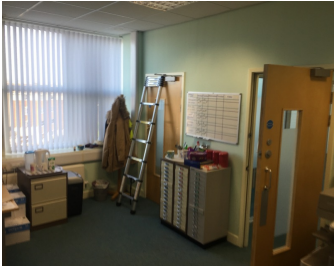
Comments: Metal radiator and pipes

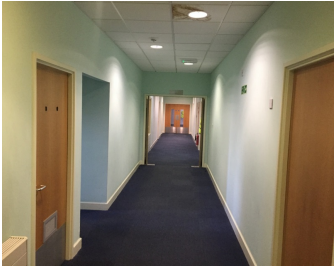
Comments: Metal radiator and pipes

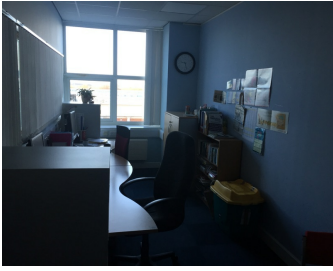
Comments: Metal radiator and pipes, concrete columns

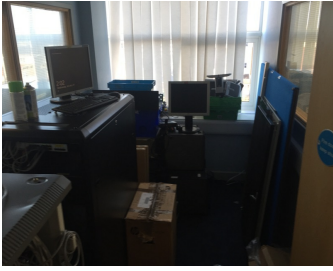
Comments: Metal radiator and pipes

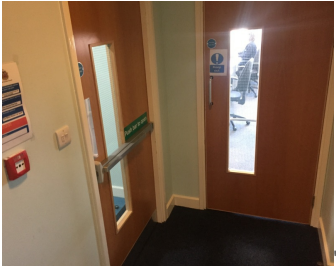
Comments: Modern air con unit, modern comms units

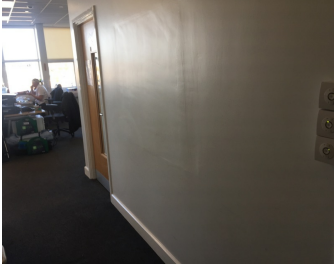
Comments: Metal radiator and pipes

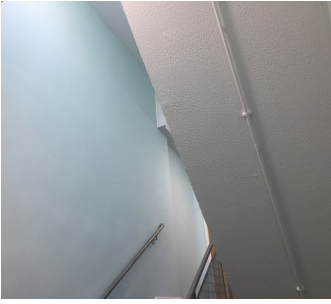
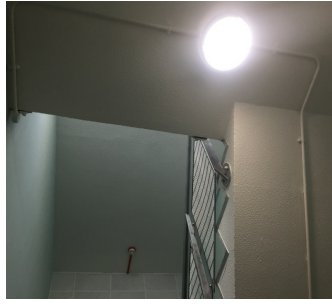
Comments: Metal radiator and pipes, modern stair nosings, metal skylight accessing room

Item ID	Textured coating to ceilings (OS)
Sample/link ID	S003 - AJ002455
Property Name	White Swan Centre
Area/floor	L4
Room/location	108
Specific location	Ceiling
Product/debris type	Plaster/plasterboard Skim
Extent	40 m ²
	■ No Risk
